R-90-08

HYDRAULIC MODEL STUDY OF THE THEODORE ROOSEVELT DAM SPILLWAY MODIFICATIONS

July 1990

U.S. DEPARTMENT OF THE INTERIOR
Bureau of Reclamation
Denver Office
Research and Laboratory Services Division
Hydraulics Branch

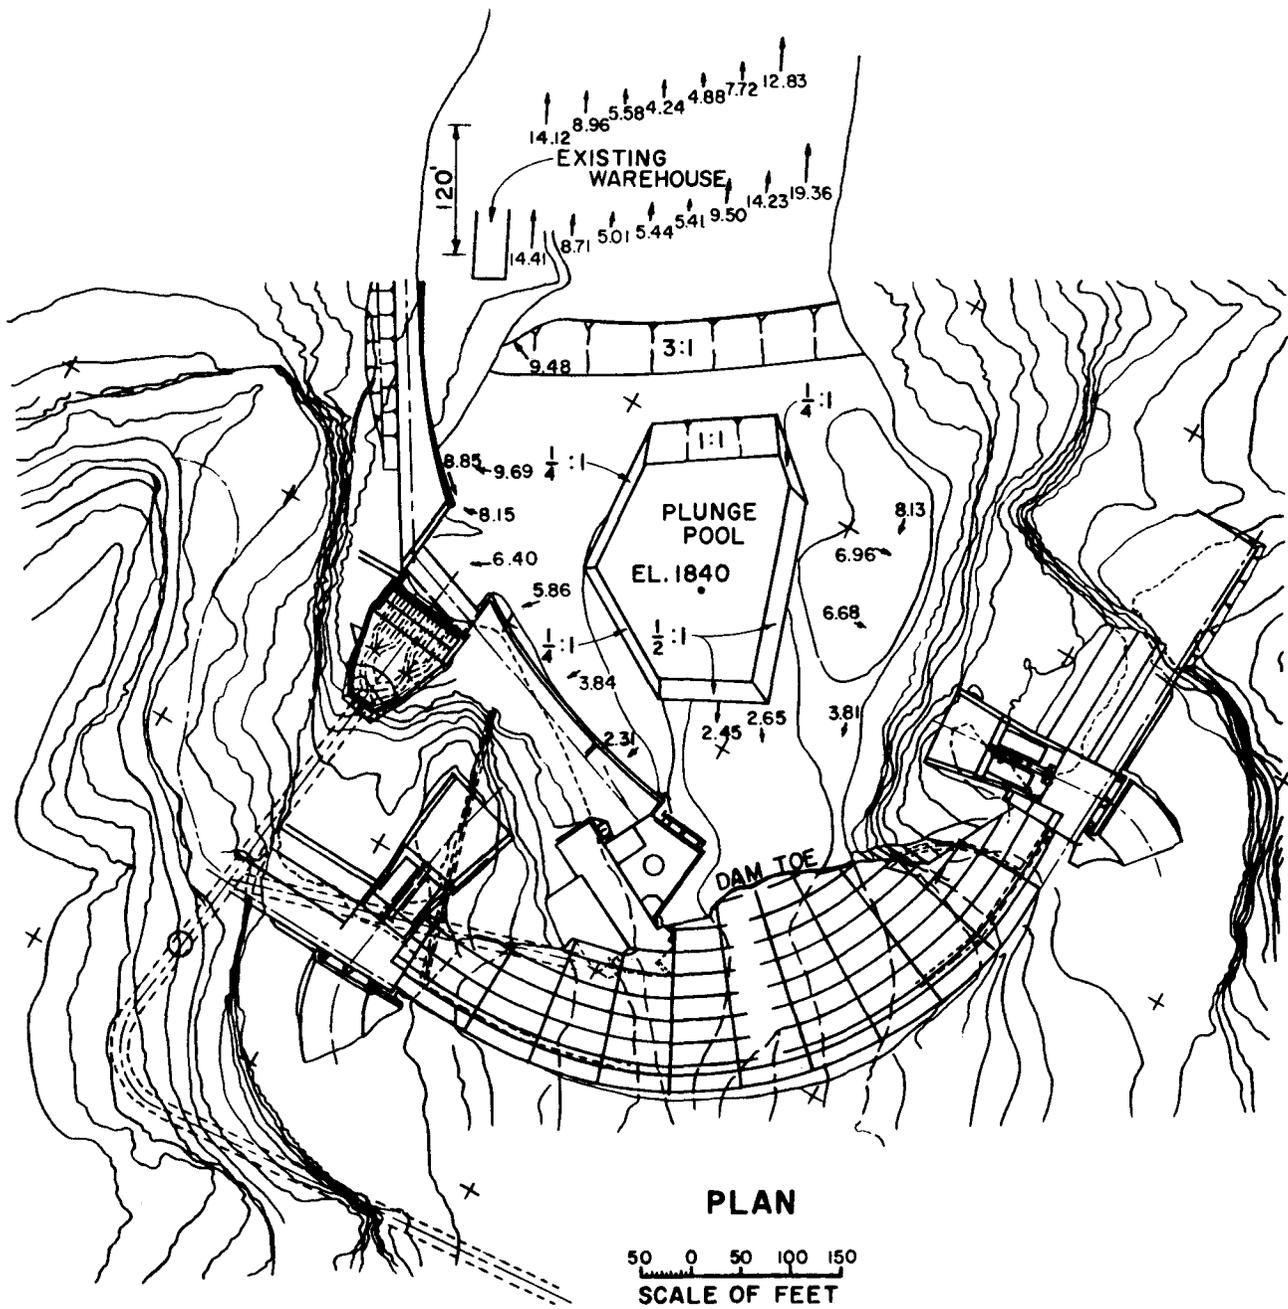
Figure 16. - Velocities, ft/s, around the SCAD plunge pool design and in the river channel for the design discharge.

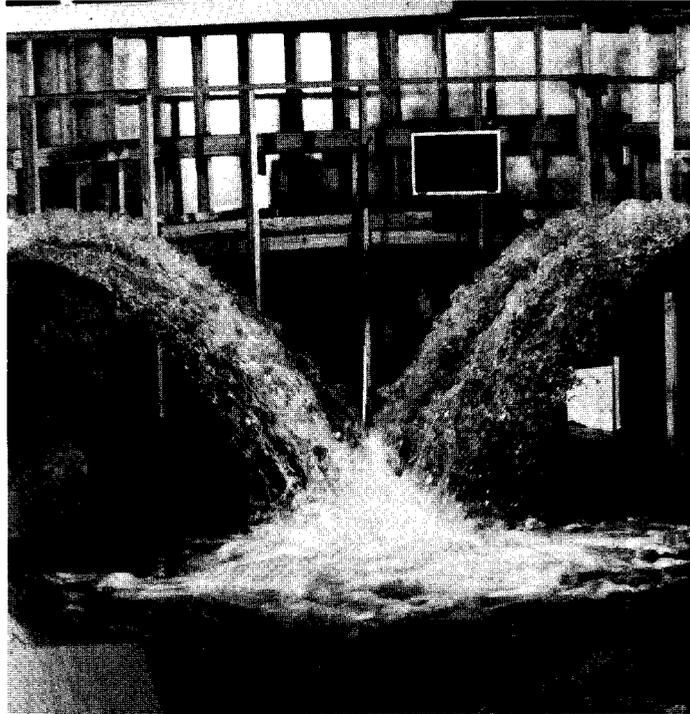
Figure 17. - Initial DCAD spillways and plunge pool with $Q = 54,380 \text{ ft}^3/\text{s}$ at elevation 2175.

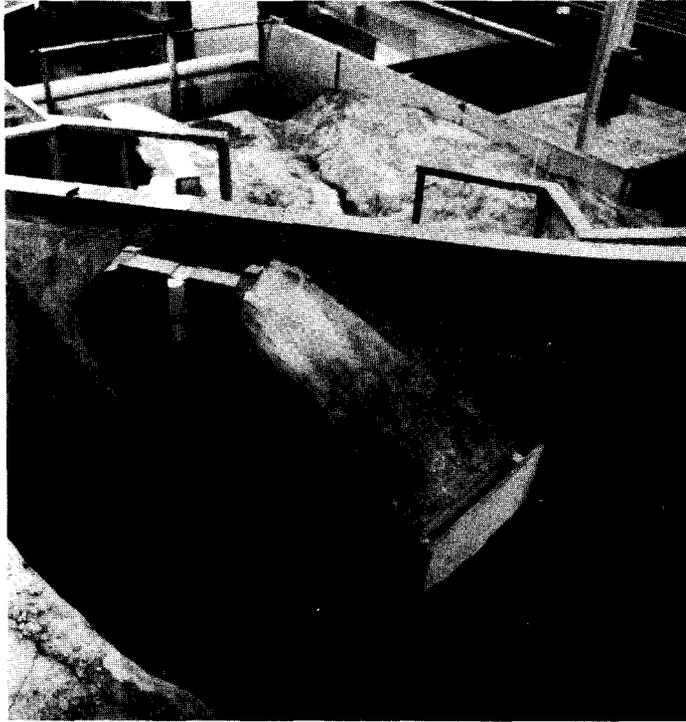
Figure 19. - Tapered guidewall tested in the left spillway approach channel to reduce vortex formation.

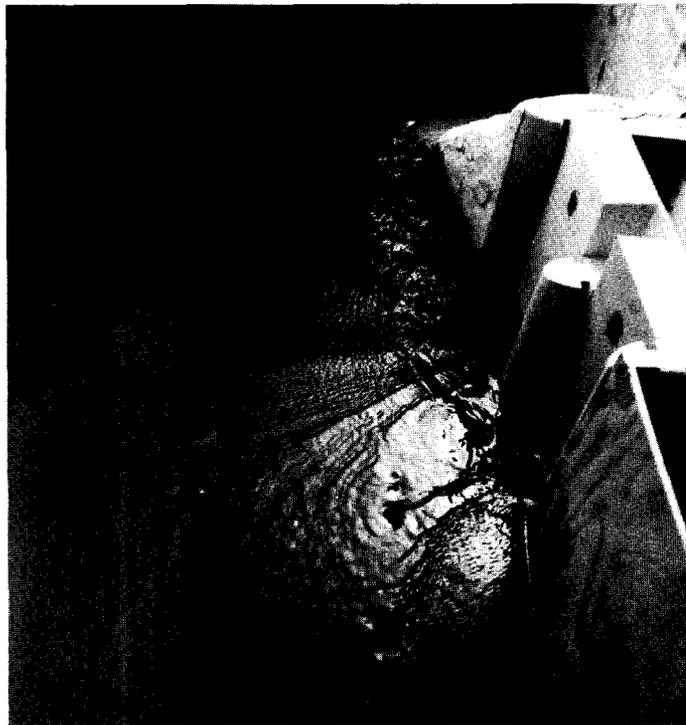
Figure 20. - Vertical thrust block face and tapered guidewall in the right spillway channel tested at reservoir elevation 2175 to reduce vortex formation.

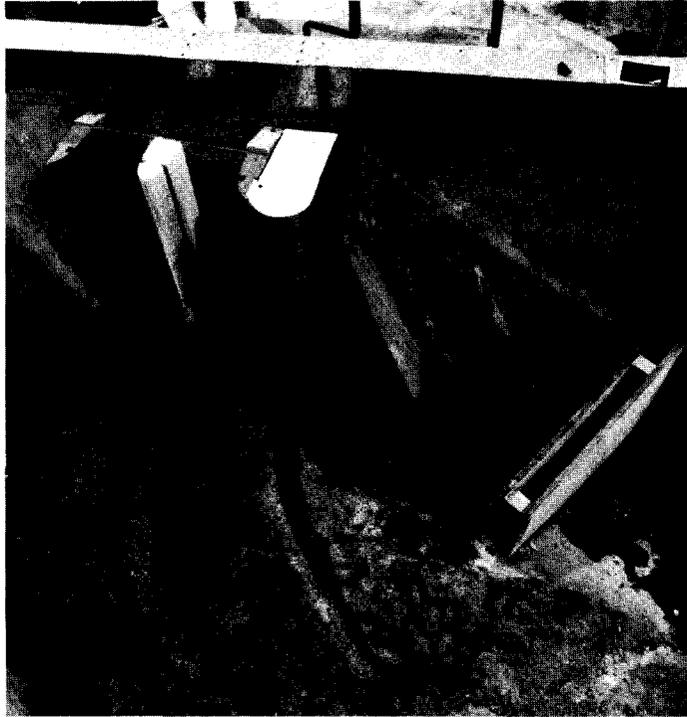
Figure 21. - Nose of the left spillway inside pier extended to the end of the thrust block tested to reduce vortices.

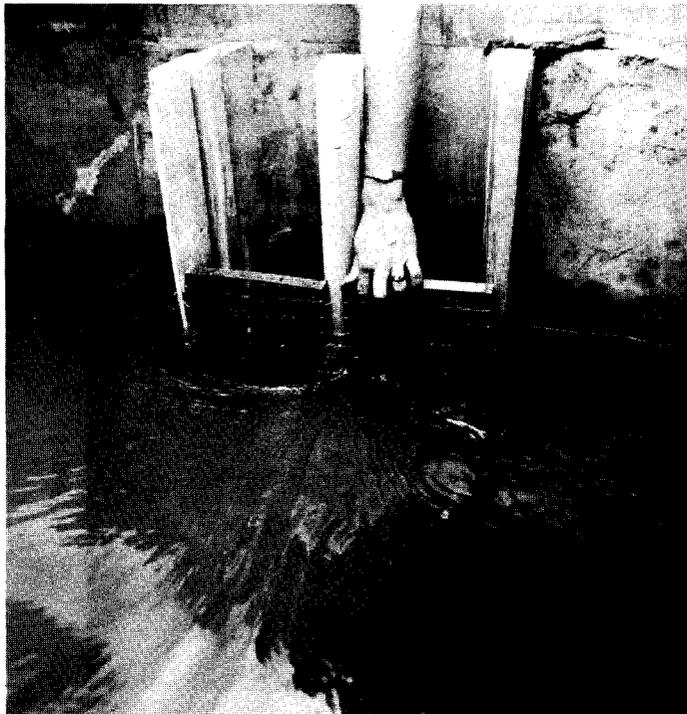
Figure 22. - Initial testing with vortex suppressor racks above the right spillway entrance at reservoir elevation 2175.

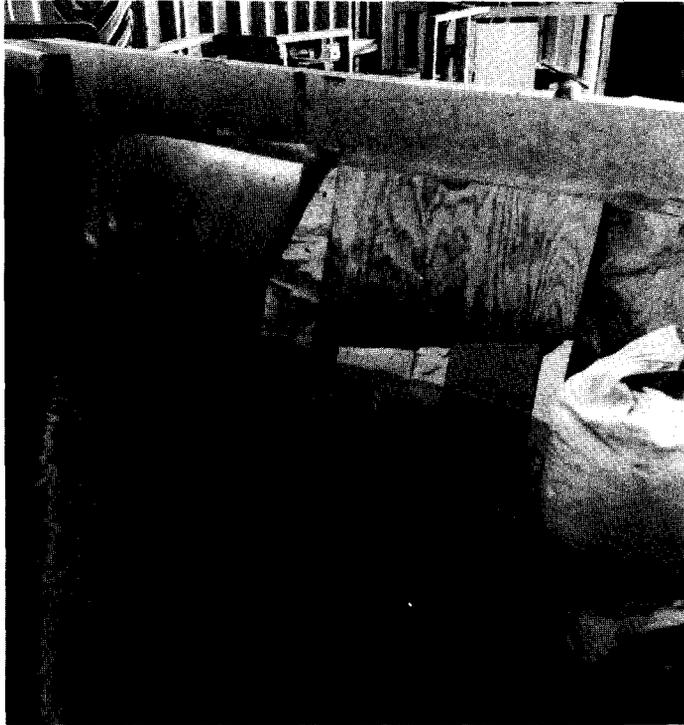
Figure 23. - Modified right spillway entrance flush with the 1:3 thrust block face and "dead space" in approach channel filled (reservoir elevation 2175).

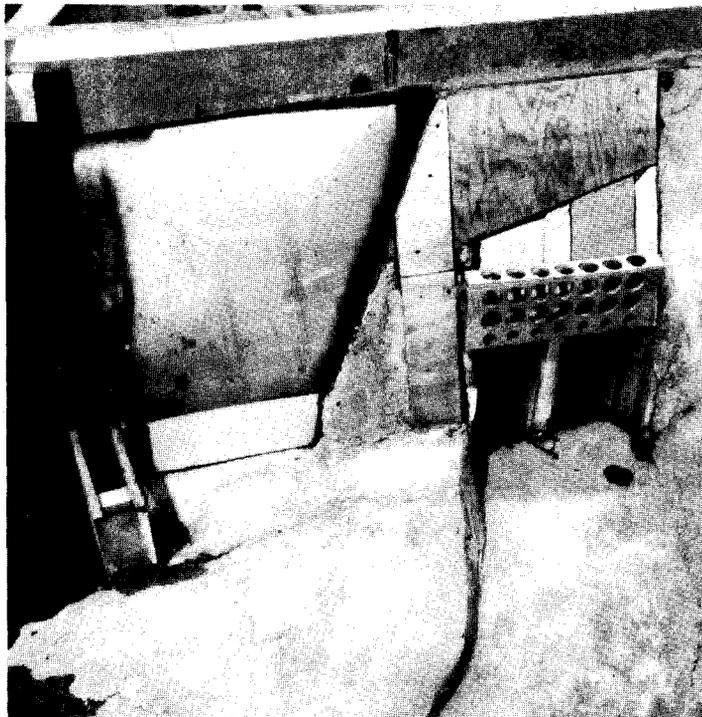
Figure 24. - Vortex suppressor structure mounted from elevation 2151 to 2175 above the right spillway entrance.

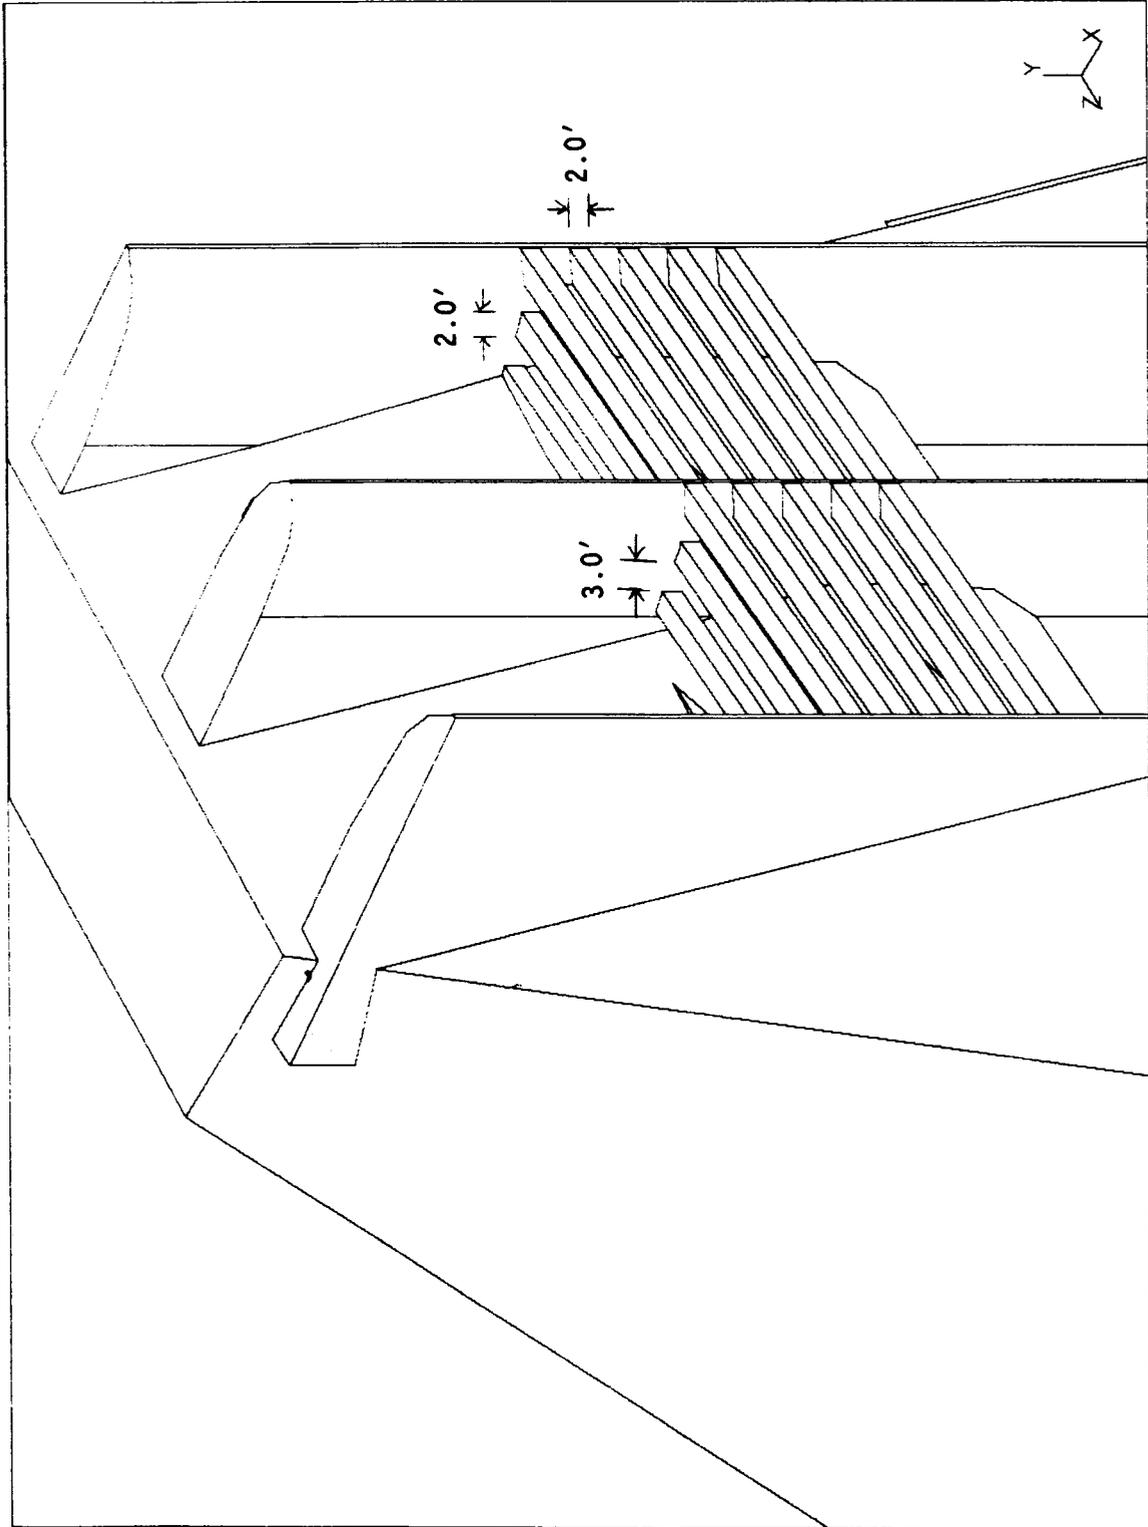
Figure 25. - Recommended vortex suppressor for the DCAD option.

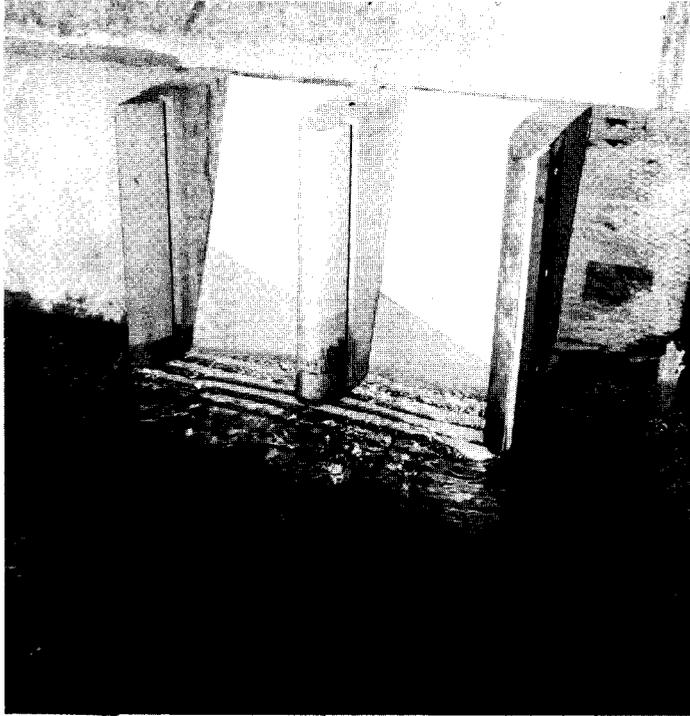
Figure 26. - Weak surface vortices, but no air core vortices over recommended vortex suppressor, $Q = 135,000 \text{ ft}^3/\text{s}$, elevation 2175, for the DCAD option.

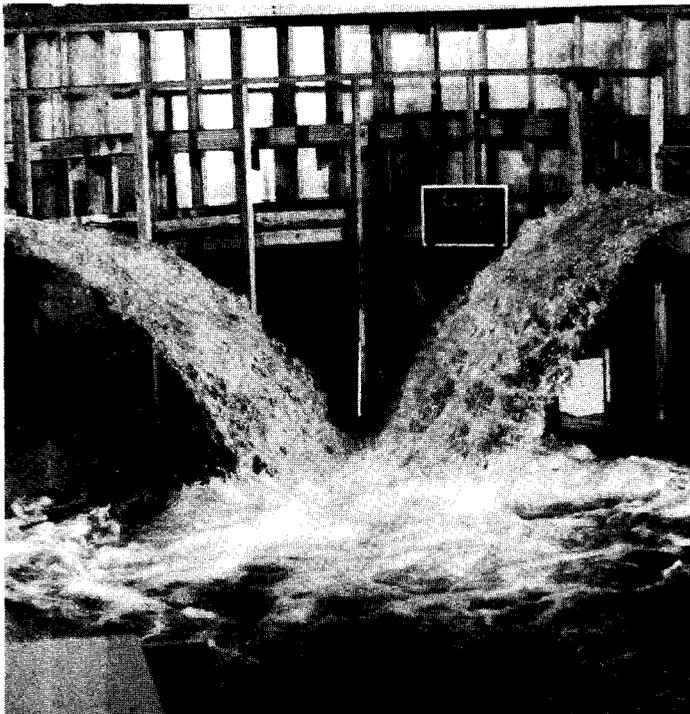
Figure 27. - Recommended spillways for the DCAD option discharging into the initial plunge pool design with $Q = 135,000 \text{ ft}^3/\text{s}$ at elevation 2175.

Uniform flow depth across the left spillway chute improved flow conditions in the plunge pool by better offsetting the jet from the right spillway. The spillways, with 21-foot-wide gates, the right spillway end width at 70 feet, and the redesigned left spillway chute superelevation are shown discharging into the original plunge pool in figure 27.

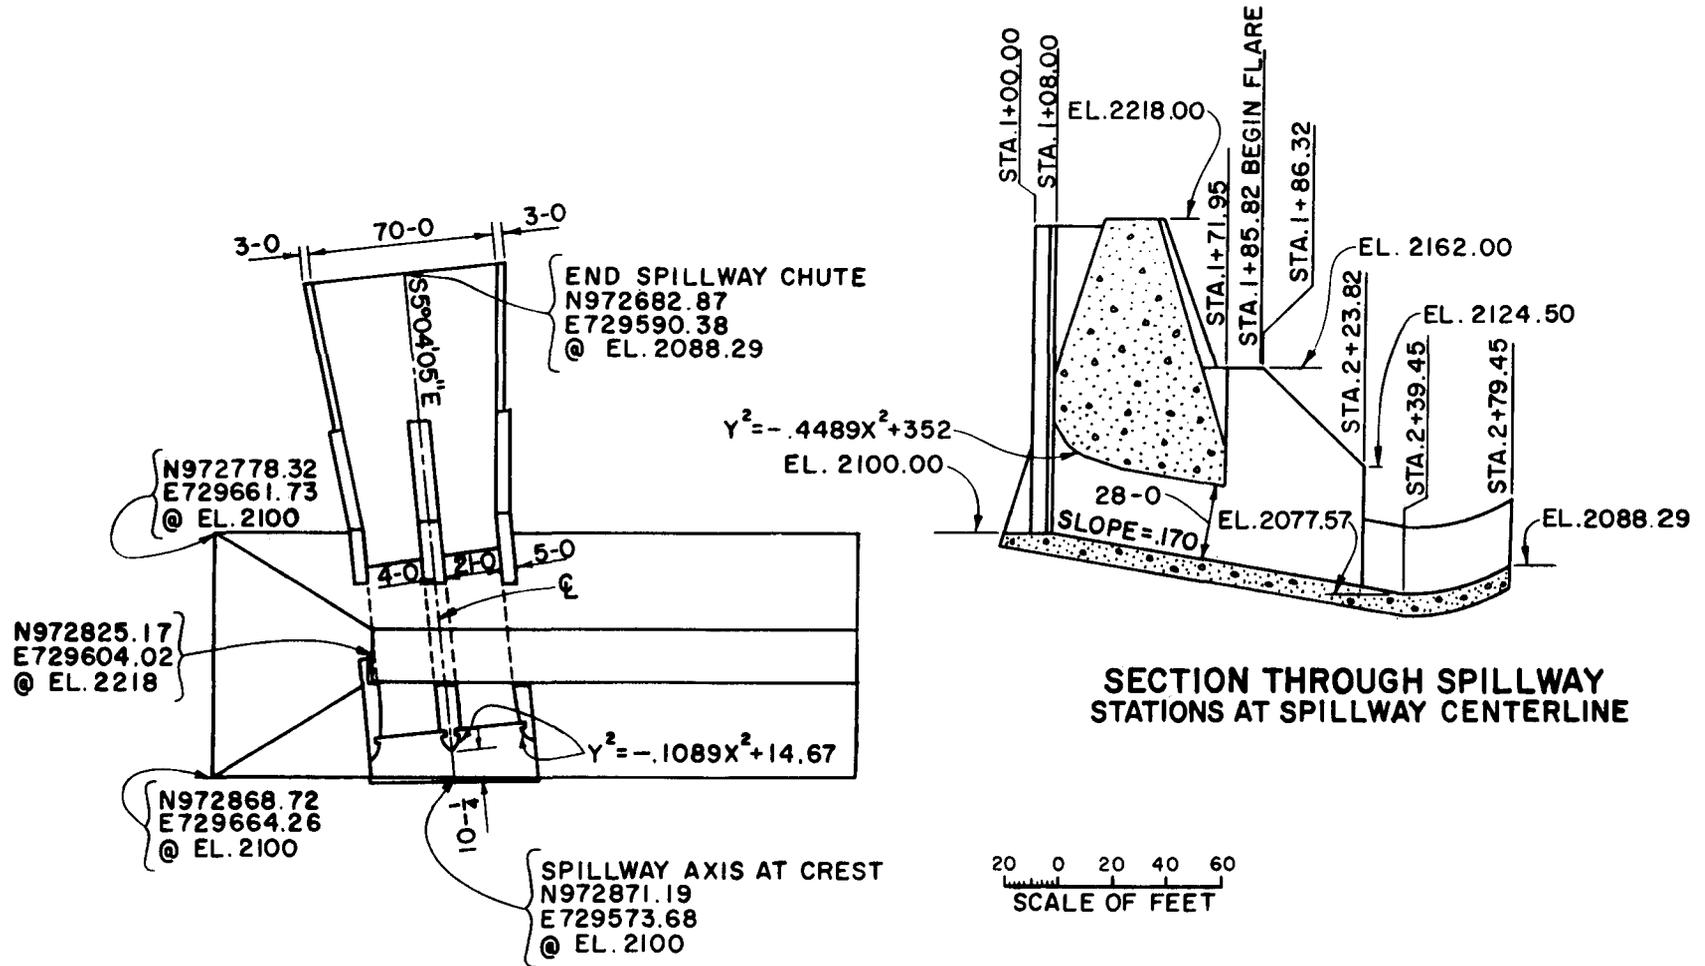
Figure 28. - Recommended right spillway geometry for the DCAD option.

At this point, it was felt that further improvement in plunge pool energy dissipation would have to be made with changes to the pool and not by further modifications to the spillway geometry. The recommended geometry for the spillways of the DCAD option is shown on figures 28 and 29.

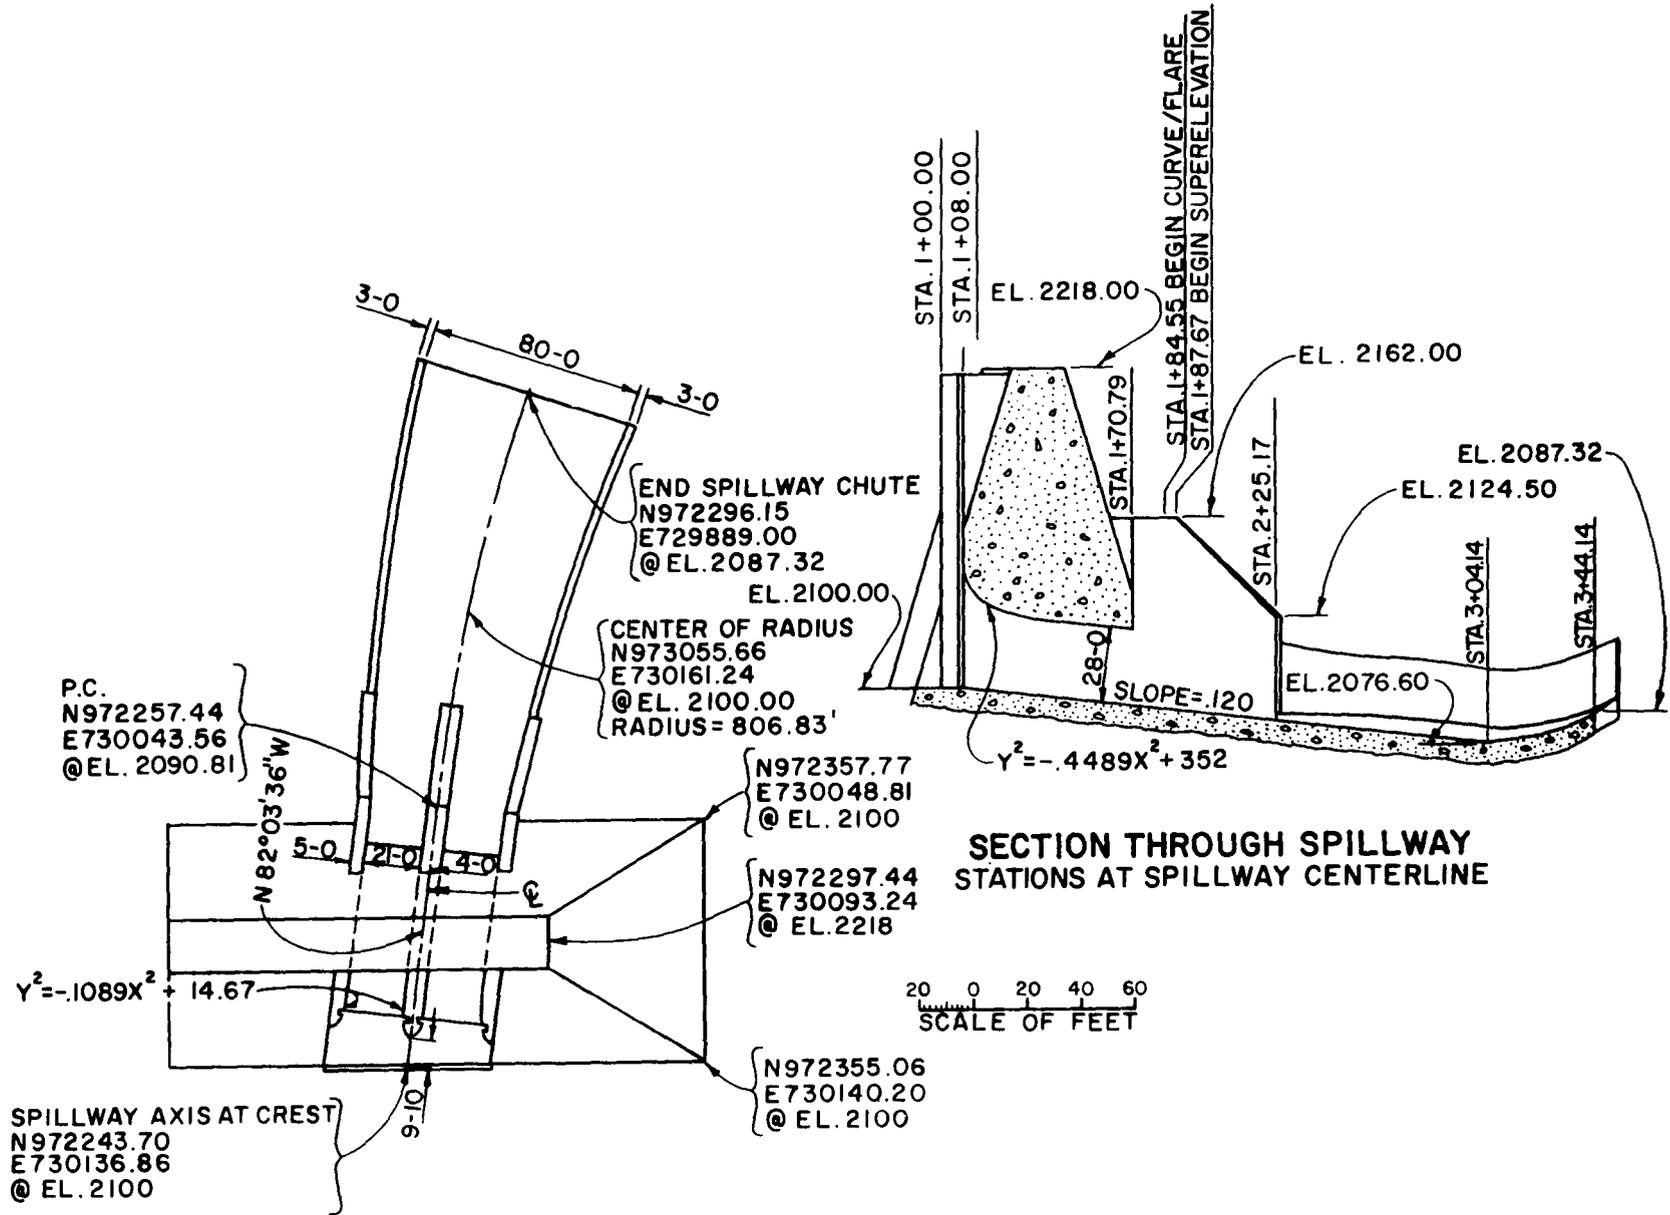
Figure 29. - Recommended left spillway geometry for the DCAD option.

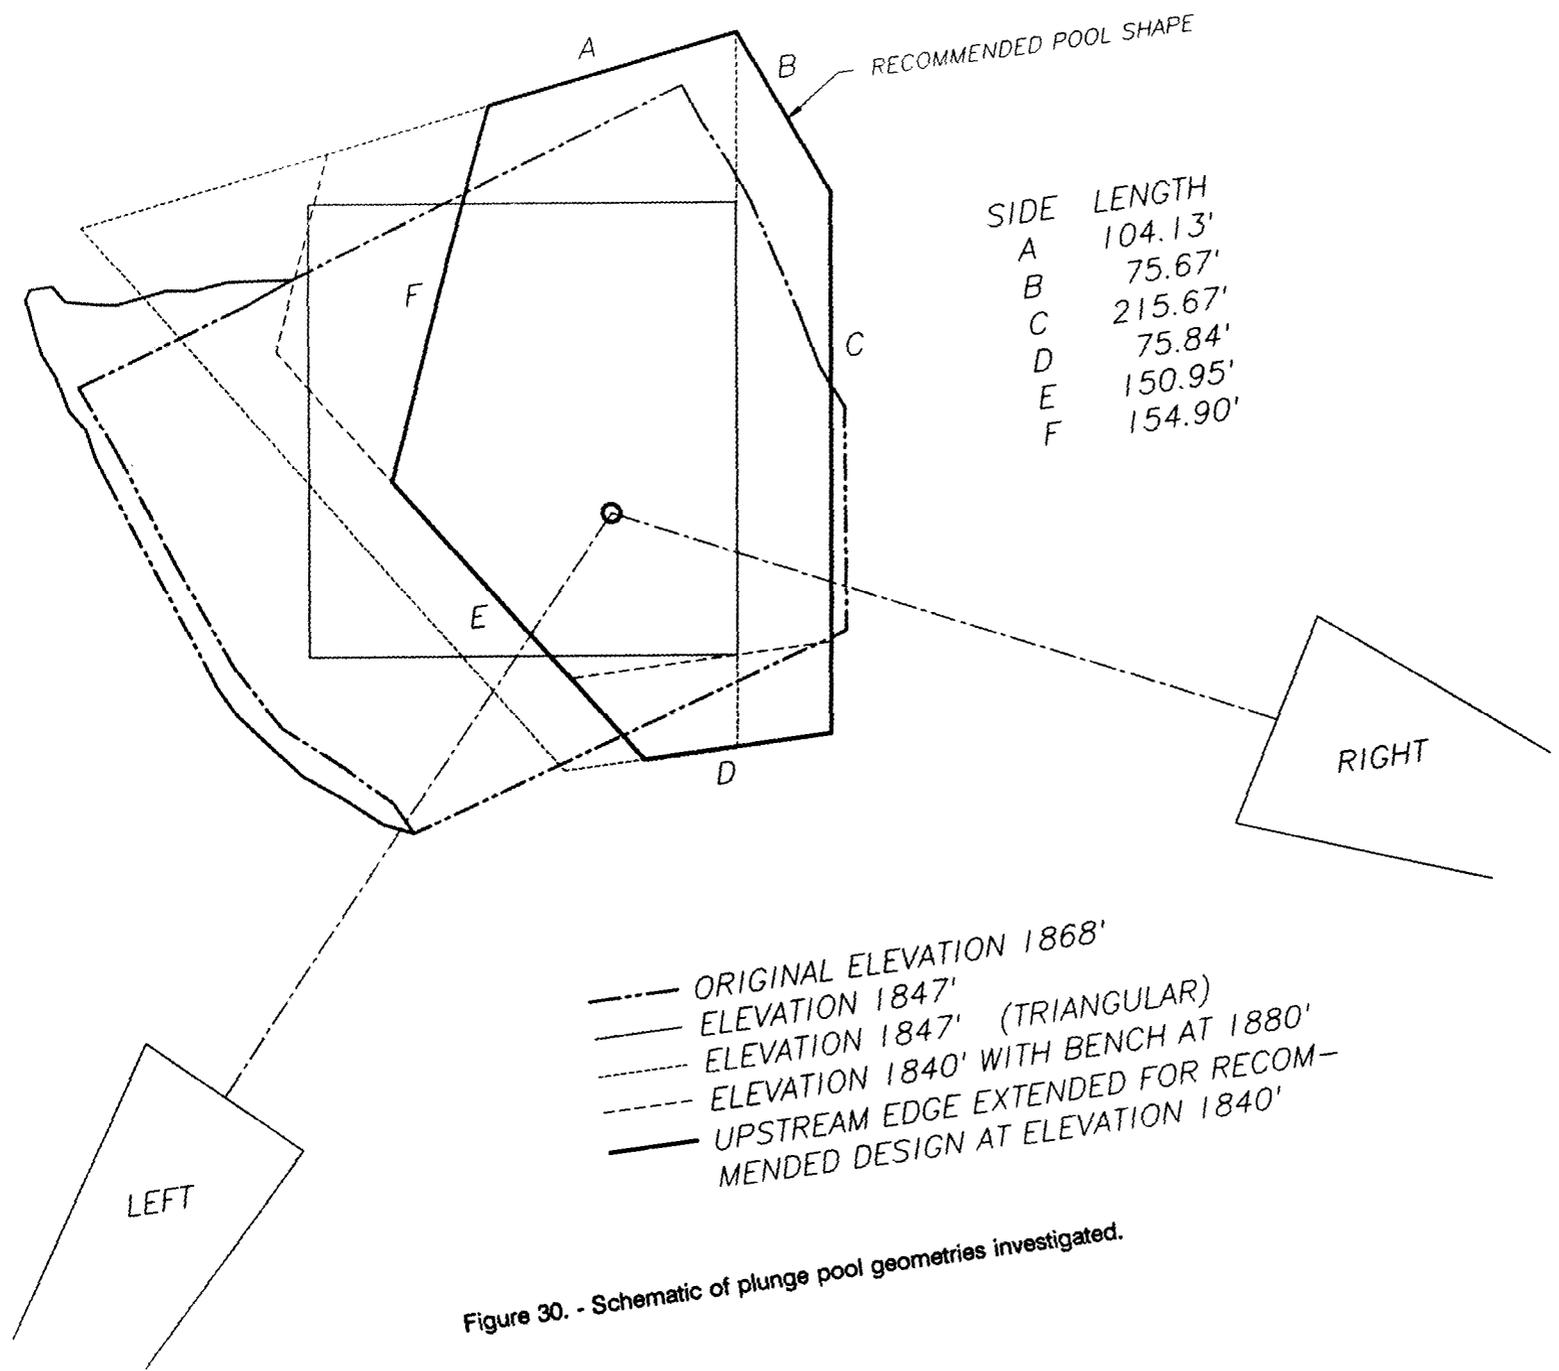
Figure 30. - Schematic of plunge pool geometries investigated.

Numerous plunge pool modifications were then tested with the jets produced by the finalized spillway geometry (fig. 30). The first modification was to make the plunge pool rectangular, 172.5 feet wide by 180 feet long; 21.76 feet deeper to elevation 1846.33; and angled to release the flow into the river channel (fig. 31). Testing with this plunge pool depth and shape indicated that the plunge pool could successfully be further modified to protect the powerplant road and produce a downstream orientation to the released flow. However, the pool from this first modification appeared too small as the flows around the pool, except at the toe of the dam, were quite turbulent (fig. 32). The plunge pool depth seemed appropriate and was maintained while the pool was enlarged and reshaped.

The extensive plunge pool geometry testing revealed that the side of the pool under the left spillway should be close to the jet to eliminate formation of a boil underneath the jet, the upstream edge of the pool should be as close to the intersection of the jets as possible to reduce excavation, and a narrow downstream end of the pool is needed to impose a strong downstream component to the flow. The recommended shape, with dimensions, is shown on figure 30 where it may be compared to the previously tested configurations.

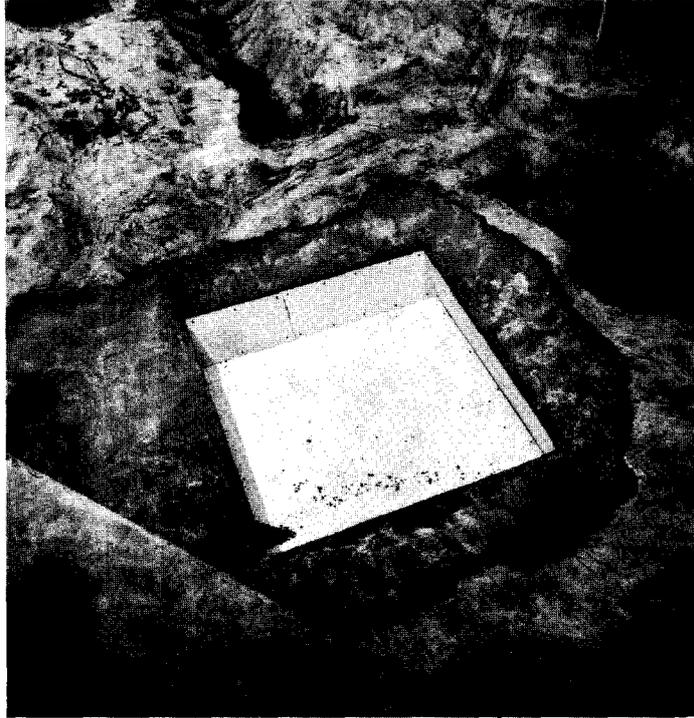
Figure 31. - First plunge pool modification, floor elevation 1846.33.

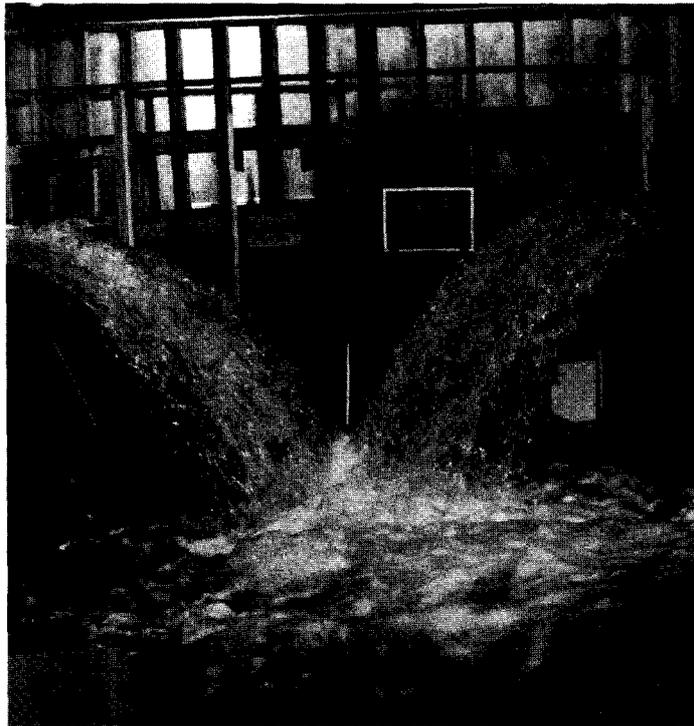
Figure 32. - First plunge pool modification with floor elevation 1846.33, $Q = 135,000 \text{ ft}^3/\text{s}$, elevation 2175.

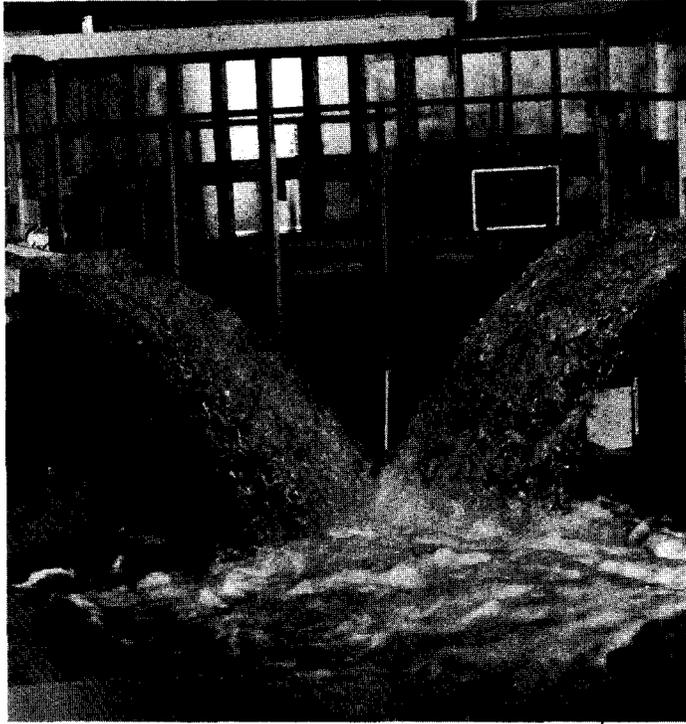
Figure 33. - Triangular plunge pool modification, $Q = 135,000 \text{ ft}^3/\text{s}$, elevation 2175.

flattened apex of the triangle and was thus significantly narrower. In the previous tests, a boil had formed between the underside of the jet and the plunge pool boundary. With the sides of the pool close to the jet, flow conditions underneath the jets were improved. Tailwater along the toe of the dam was very calm. The remaining area of concern continued to be flow near the powerplant road and outlet works exit channel. This flow was caused by the left spillway jet not entirely balancing that of the right spillway. Since expanding the pool toward the road did not seem to improve conditions measurably (fig. 33), the next approach was to force the jump in the pool sooner.

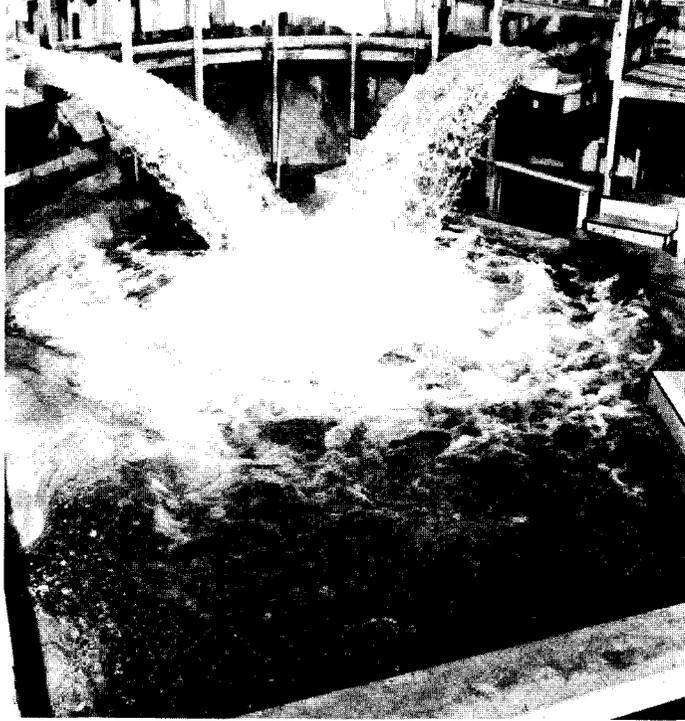
Figure 35. - Dissipation of the design discharge in the recommended pool for the DCAD option.

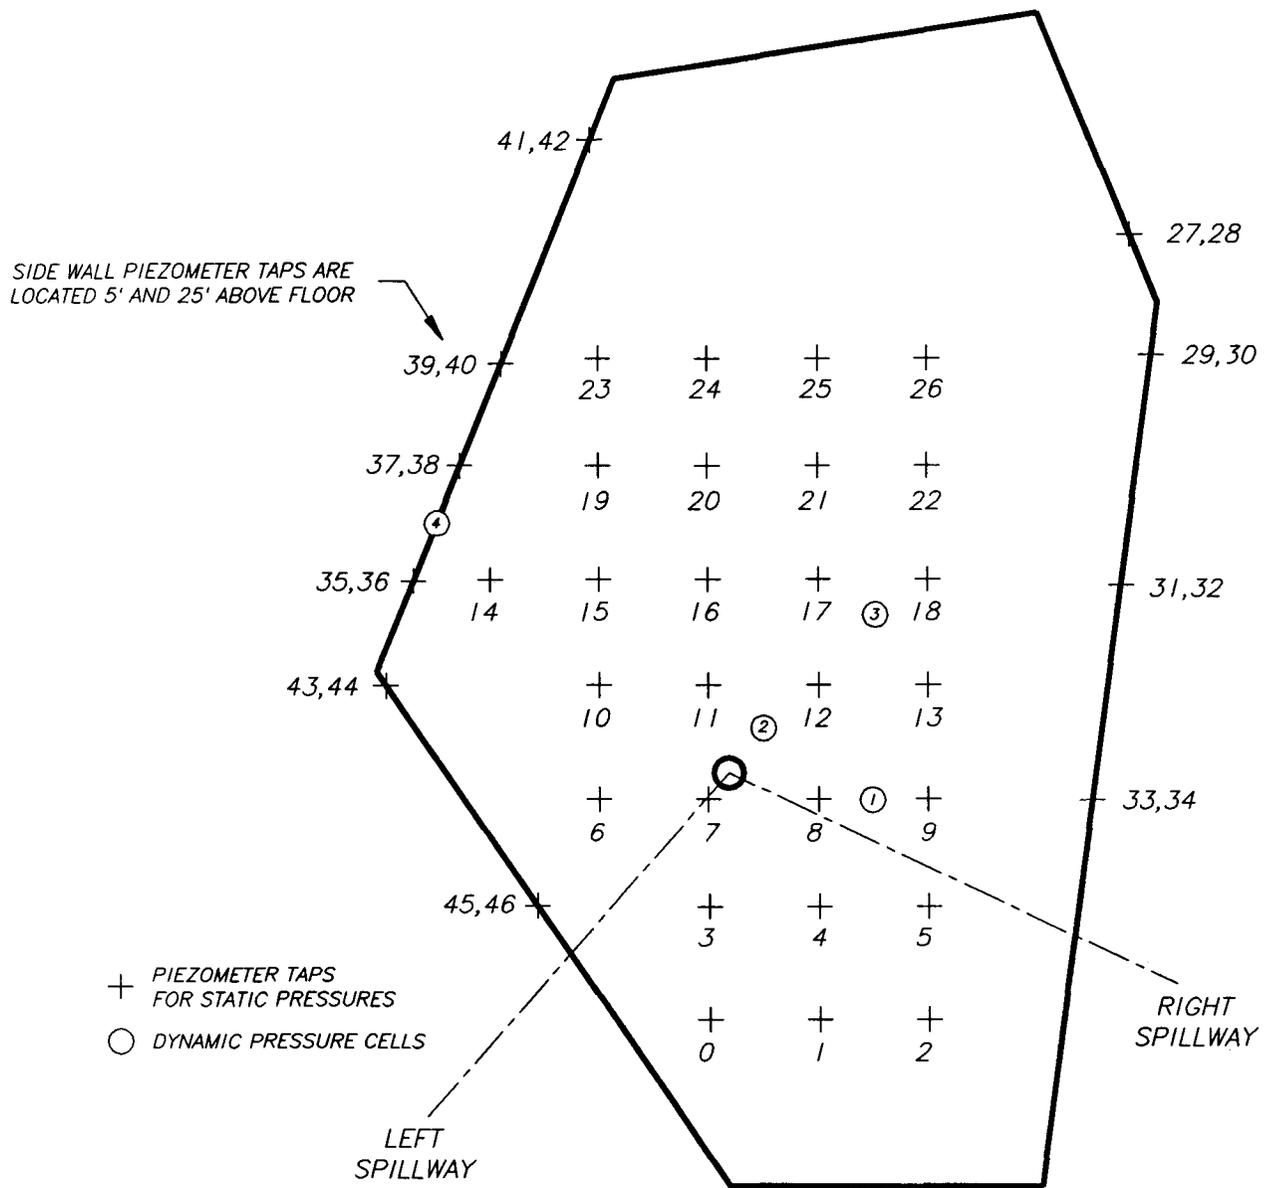
Figure 36. - Map of piezometer tap and dynamic pressure locations in the plunge pool.

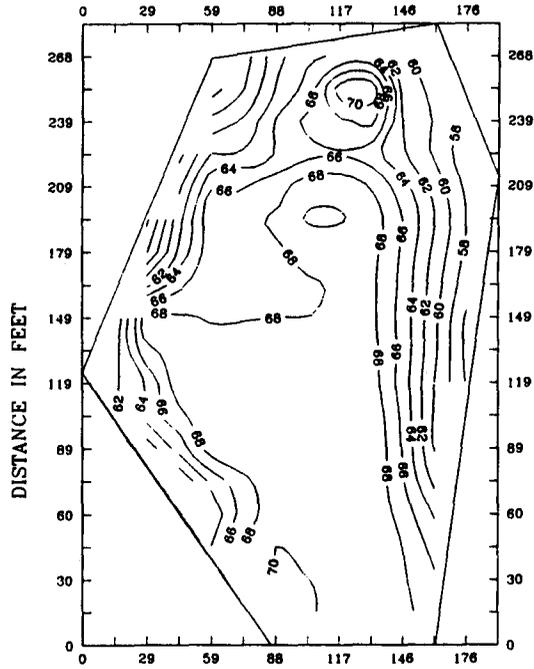
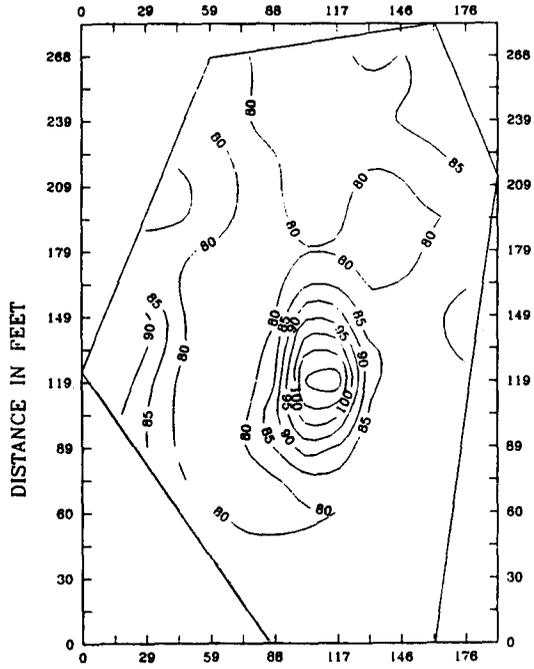
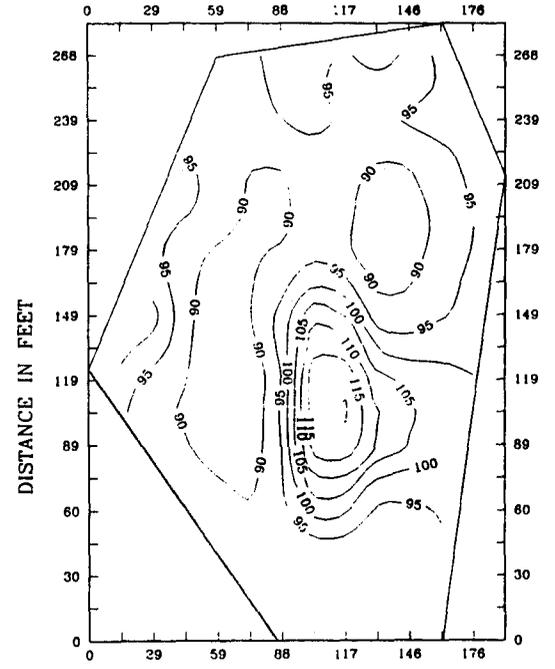
Q = 22,000 ft³/s
 TW = 1912

Q = 90,000 ft³/s
 TW = 1926

Q = 135,000 ft³/s
 TW = 1937

Figure 37. - Equal static pressure contours for pool floor at elevation 1841.

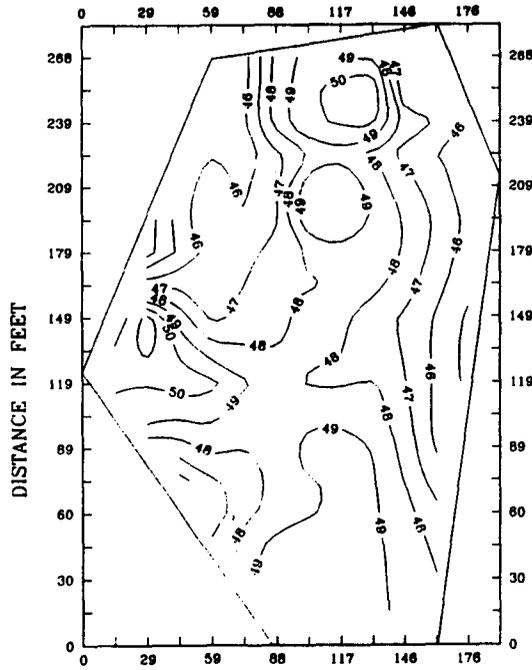
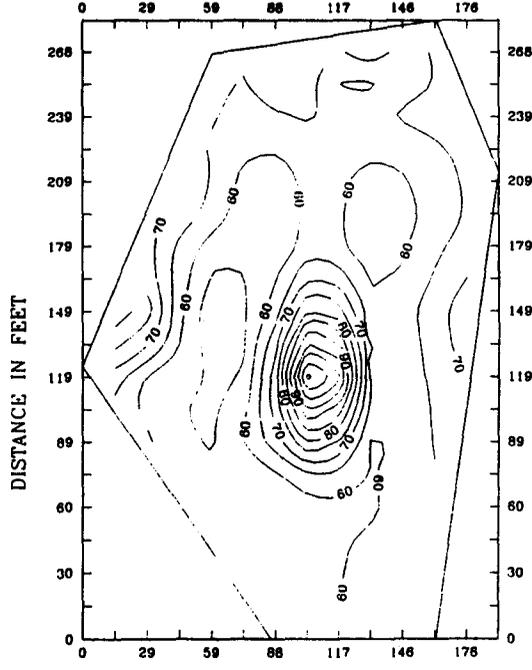
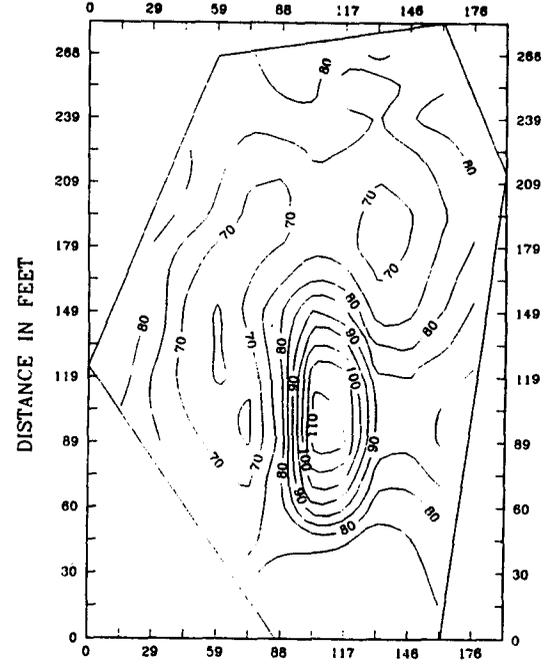
Q = 22,000 ft³/s
 TW = 1914

Q = 90,000 ft³/s
 TW = 1925

Q = 135,000 ft³/s
 TW = 1938

Figure 38. - Equal static pressure contours for pool floor at elevation 1861.

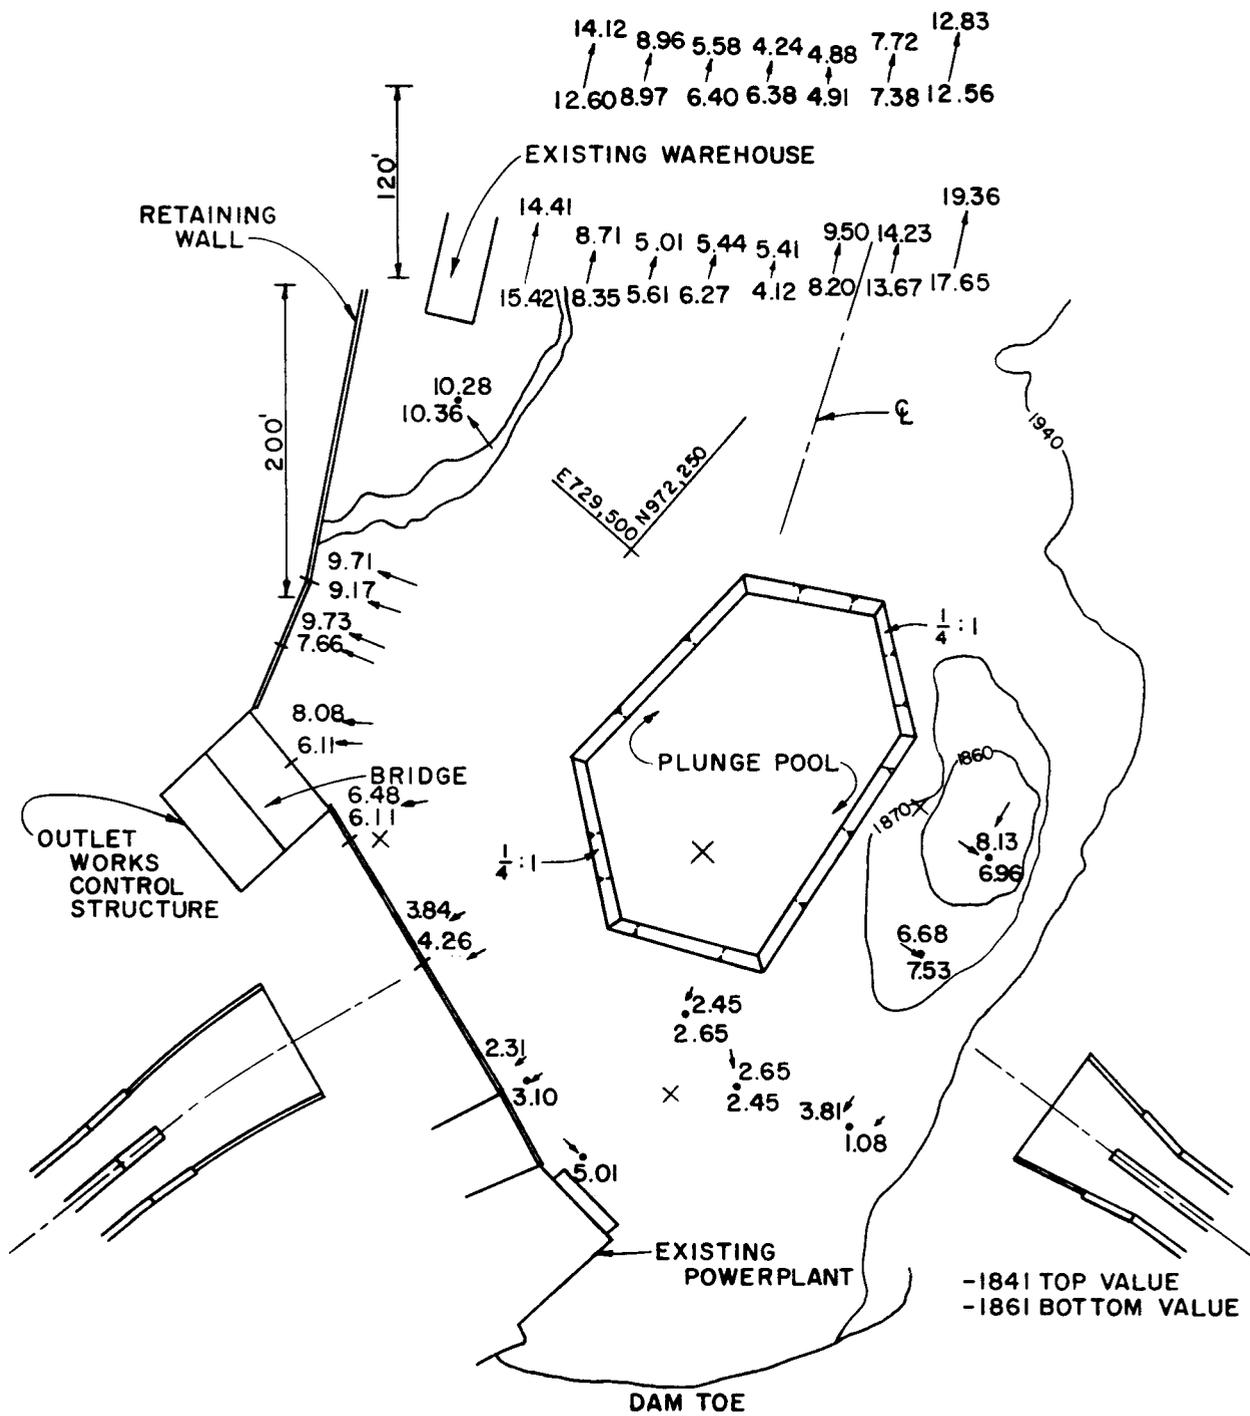
Figure 39. - Velocities adjacent to and downstream of the DCAD plunge pool for floor elevations 1841 and 1861.

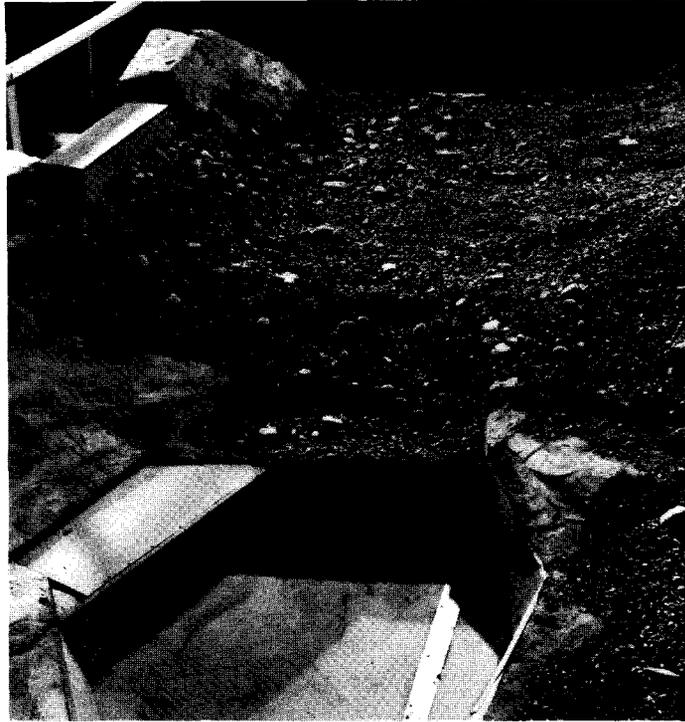
Figure 40. - Original alluvium contours with recommended DCAD plunge pool.
